Hi-Fi Products
Service Bulletin

Model: D-35

No. 149

Subject: Battery Pack BP-5 Cannot Be Fully Charged

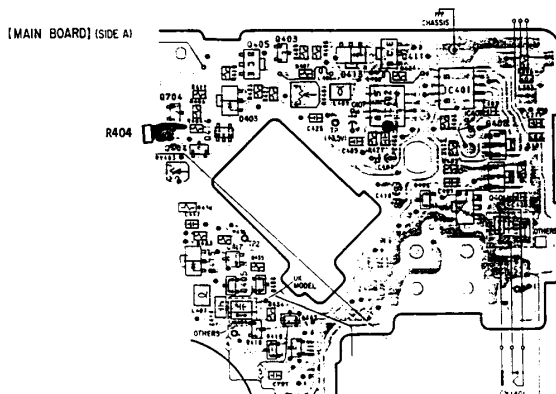
Symptom:
(22)

The repetitive charging and discharging of BP-5 causes insufficient charging ability.

Solution: If this symptom occurs, replace the following resistors:

Description			
Ref. No.	Former	New	Part Number
R418	330 Ohm	560 Ohm	1-216-192-00
R419	330 Ohm	560 Ohm	1-216-192-00
R420	330 Ohm	560 Ohm	1-216-192-00
R414	47 Ohm	150 Ohm	1-216-029-00
R404	3.0k Ohm	6.8k Ohm	1-216-671-11
