Hi-Fi Products  
Service Bulletin

Model: STR-AV910/1010

No. 150

Subject: Missing Adjustment Procedures For Amp Bias Current      Date: December 10, 1990

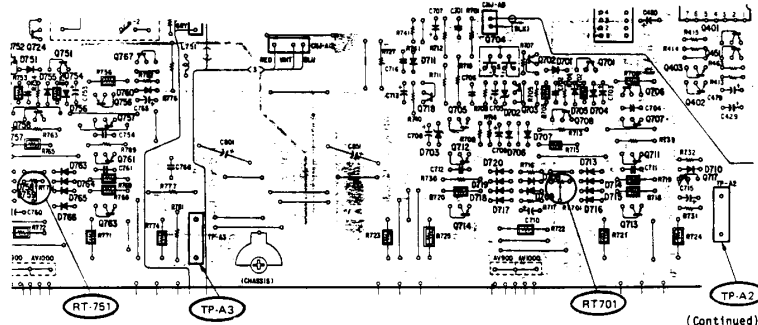
(MAIN BOARD) (Conductor side)

The adjustment procedures for the Amp Bias Current are not listed in the service manual.

- Connect the digital voltmeter to Bias Check Point ( L : L-CH, R : R-CH)
- Increase the AC power voltage gradually to 120 V confirming that the voltmeter will not indicate an abnormal value.

- Confirm that the display is normal.
- Adjust RT701 (L-ch) or RT751 (R-ch) so that the reading on the voltmeter becomes 0.1 mV within 30 seconds after the power turned on.
