Hi-Fi Products
Service Bulletin

Model: TC-RX70ES

No. 151

Subject: Unit Causes Tape Damage

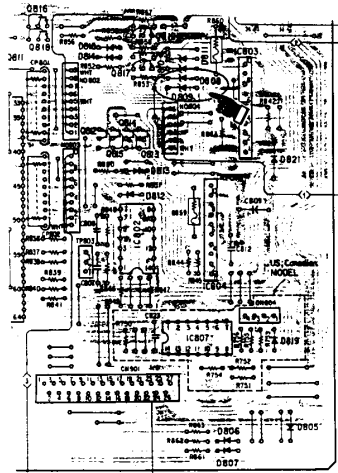
Tape damage occurs because the pinch roller is held pressed against the capstan shaft due to the head base failing to go down when the unit is turned Off.

Cause: The values of D808 and D809 are too HIGH, causing an immediate stop of the motor.

Solution: If this symptom occurs, replace Zener Diodes D808 and D809 with HZS9A2L as follows:

Ref. No.	Description	Part Number
D808, D809	HZS9A2L	8-719-933-54
