Hi-Fi Products  
**Service Bulletin**

**Model:** TC-K620/K650ES

**No.156**

**Subject:** Capstan Motor Misoperation

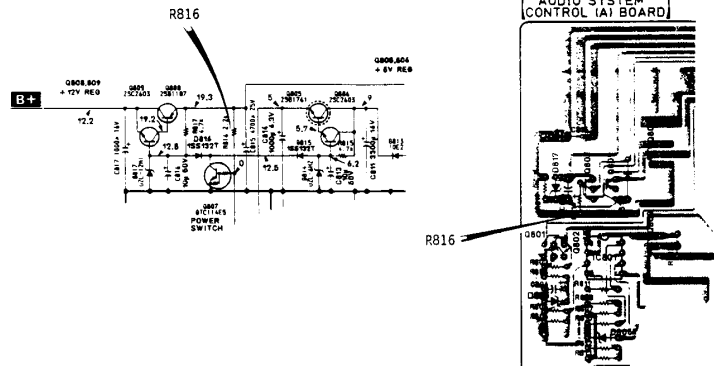
Reference:

The capstan motor continues to rotate slowly and the cassette holder LED lights dimly after the power has been switched off.

**Cause:** The problem is due to the unstable switching of Q807.

**Solution:** If this symptom occurs, replace R816 as listed below:

Ref. No.	Description		Part Number
	Former	New	
R816	22k Ohm	4.7k Ohm	1-249-425-11
