Hi-Fi Products
Service Bulletin

Model: STR-GX5ES11

No. 175

Subject: Shorted Traces On Replacement
Power Board

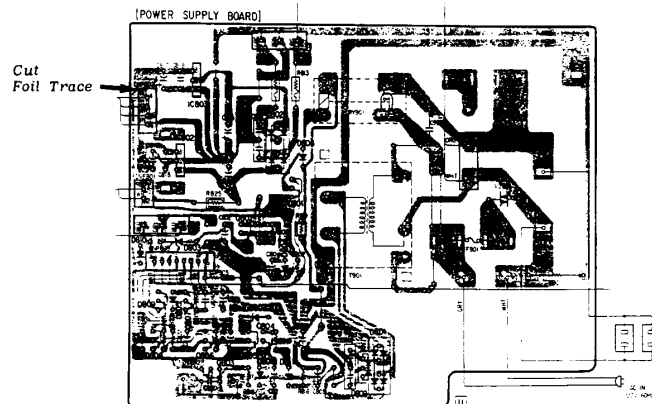
Symptom:
(**)

Power relay will chatter continuously.

Solution: If this symptom occurs, cut the foil trace on the "PC" Board
(power supply) where CN-802/Pin 4, and C817 and C819 are
located.
