Hi-Fi Products
Service Bulletin

Model: DTC-700/75ES

No. 183

Subject: Creasing Tape In Review Mode

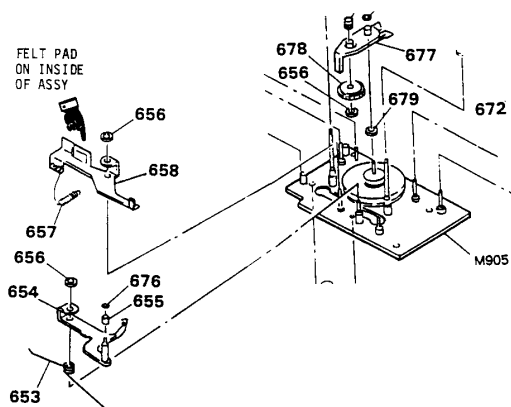
When in Reverse AMS or Review Mode, the DAT tape is creased due to poor back tension. The felt brake pad glued to the Lever Assembly (Ref. No. 658) loosens or falls off.

Solution: If this symptom occurs, reattach the felt brake pad.
