Hi-Fi Products  
**Service Bulletin**

**Model:** STR-313, TA-313

**No.186**

**Subject:** Output Oscillation After  
Replacement of Output AMP

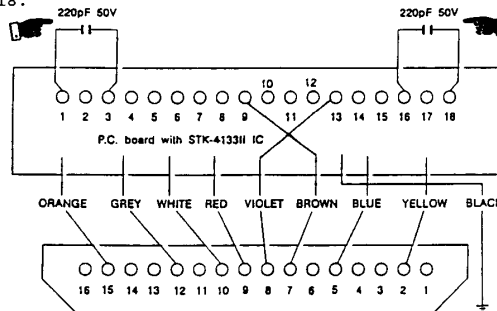
After the replacement of the output amp (SI-1125 or SI-1225), with the replacement kit STK-4133II, oscillation at the output can occur. This is because the specifications for the replacement kit and those of the original amp do not match.

1. Remove the output IC from the board and heatsink.
2. Remove capacitors C661, C662, C612 and C611 from the circuit board (C204, C207, C254 and C257 on the TA-313).
3. Add two capacitors (220pf 50V) to the circuit board that the replacement STK-4133II is mounted on. One cap is to go across pins 1 and 3, the other goes across pins 16 and 18.
