## Hi-Fi Products Service Bulletin

**Model:** ST-818M/-H300/-H500

**No. 188**

**Subject:** Beat Noise On Tuner

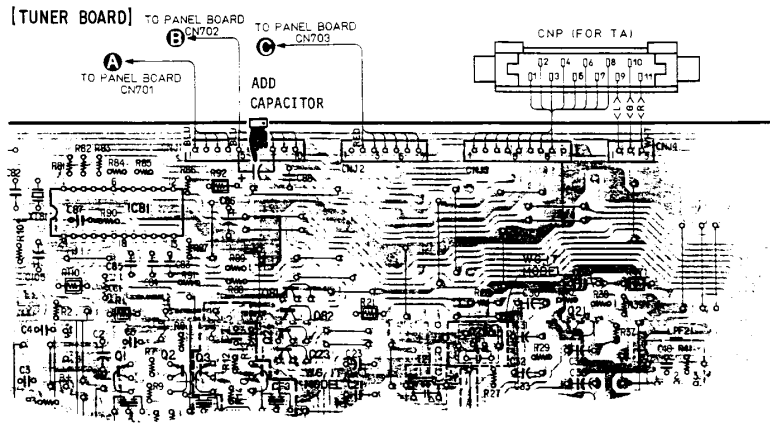
CSA-13 Tuner

When listening to the system at a low level, background noise can be heard.

**Solution:** The problem is due to insufficient ground. To solve this problem, (remove C89 if present in the unit) and place a 100uf 10v capacitor across pins 5(+) and 8(-) of connector CNJ1.
