Hi-Fi Products  
Service Bulletin

**Model:** TA-E1000ESD

**No. 193R1**

**Subject:** Error In Operation When Using  
Remote Commander RM-P1000

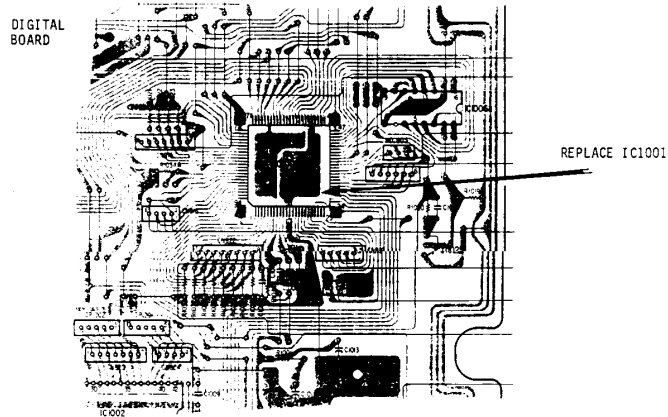
When pressing the volume control to either increase or decrease its value, the surround mode may change. (Ex. from "Live Concert" to "Stadium")  
Remote commanders from CD or DAT players may also cause this symptom.

Replace the IC1001 of the Digital board with the following.
