Hi-Fi Products
Service Bulletin

Model: TA-N80ES

No. 200

Subject: Noise in Output

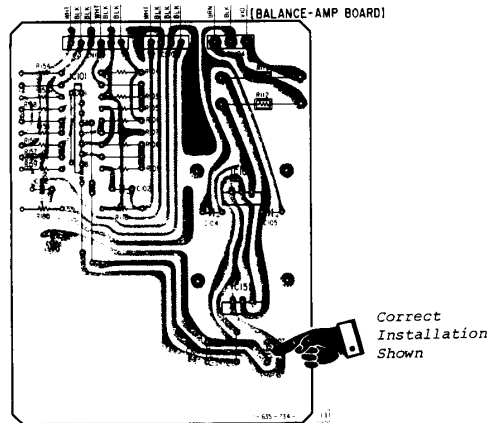
A 3-4 KHz ticking or oscillation noise in the audio. This is due to C107 incorrectly mounted on the balance amp board. The serial numbers affected, range between 4500001 and 4501000.

Solution: Reverse the polarity of C107.
