Hi-Fi Products
Service Bulletin

Model: FH-616R, HST-616

No. 202

Subject: Service Manual Correction

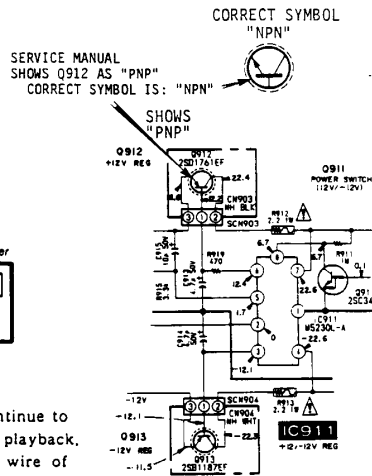
Symptom: (**)
On page 7 of the Service Manual, the test point for tape speed adjustment is incorrect. On page 17, Transistor Q912 is drawn incorrectly.

Solution: The following corrections should be made:

Connect TP501 to ground with jumper wire and continue to press HIGH SPEED DUBBING switch: High speed playback. After the high speed adjustment, remove jumper wire of TP501.
