Hi-Fi Products
Service Bulletin

Model: TC-K950ES

No. 216

Subject: Level of High Frequency Content Decreases

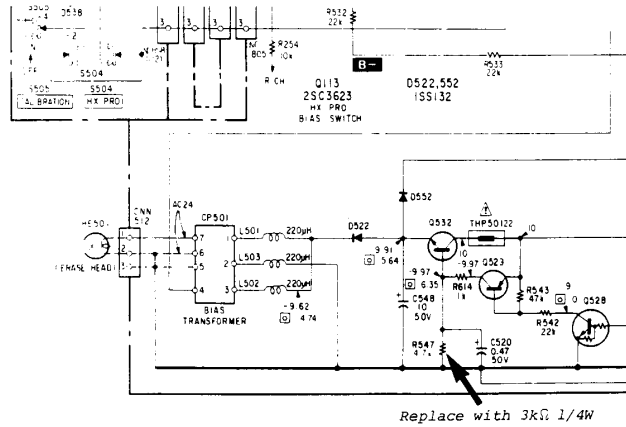
SCHEMATIC DIAGRAM - AUDIO SECTION -

Symptom:
(153) When recording the B side after recording the A side of a cassette, the level of the A side high frequency content decreases. This problem is caused by excessive erase current.

Solution: Decrease the erase head current by changing R547 as described.

REF. NO.	FORMER		NEW	
	DESCRIPTION	PART NO.	DESCRIPTION	PART NO.
R547	1/4W RESISTOR 4.7K	1-249-425-11	1/4W RESISTOR 3K	1-247-842-11
