Hi-Fi Products
Service Bulletin

Model: MHC-3600, TA-H3600

No. 223

Subject: Mechanical Buzzing Noise

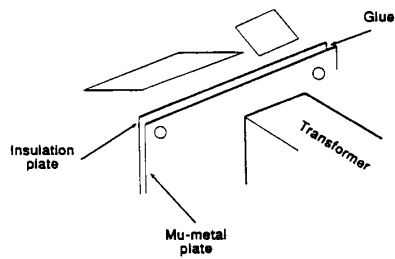
A buzzing noise is audible from the set. The problem is caused by vibration of the Mu-Metal Plate located between the power transformer (Ref. T1) and the power amp board (Ref. 23) shown on page 28 in the Service Manual.

To solve the problem, attach the Mu-Metal Plate to the transparent insulation sheet by using double-sided adhesive tape or by gluing them together using Sony Bond (P/N 7-432-916-01).
