Hi-Fi Products  
Service Bulletin

**Model:** STR-GX57ES/GX67ES

**No. 233**

**Subject:** Unit Goes Into Protection With High Volume  
On Rear Amp

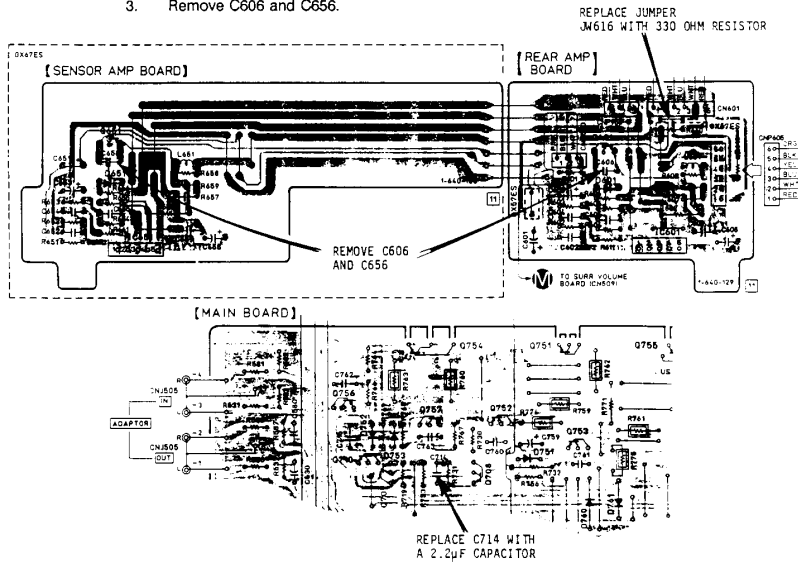
**Symptom:**  
(12) Setting the rear amp volume too high causes the protection circuit to activate.

- Solution:**
1. Replace C714 from a 0.1 $\mu$ F to a 2.2 $\mu$ F.
  2. Replace jumper JW616 with a 330K ohms resistor.

3. Remove C606 and C656.
