Hi-Fi Products  
Service Bulletin

Model: STR-AV970X/AV1070X

No. 238

Subject: Hissing Noise In Rear Surround Channel

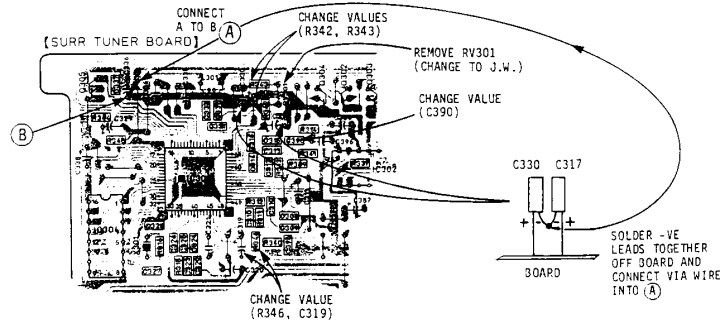
The rear surround channel has a high frequency hiss present which is most noticeable with the master volume turned up to at least 50%, the rear channel level at 0dB and no signal source present.

1. Change resistors R342 and R343 from 330K to 220K.
2. Remove pot RV301 and replace it with a wire (short).
3. Remove the negative leads of caps C330 and C317 off the board and solder them together (off the board), then solder into them a wire from the Digital ground. Then connect the digital ground into the analog ground as shown.
4. Change C390 from 0.22 $\mu$ F to 10 $\mu$ F.
5. Change C319 from 4.7 $\mu$ F to 1 $\mu$ F.
6. Change R346 from 100K to 10K.
