Hi-Fi Products
Service Bulletin

Model: TA-AX285

No. 242

Subject: Tuner Bleeds Through To Other Inputs

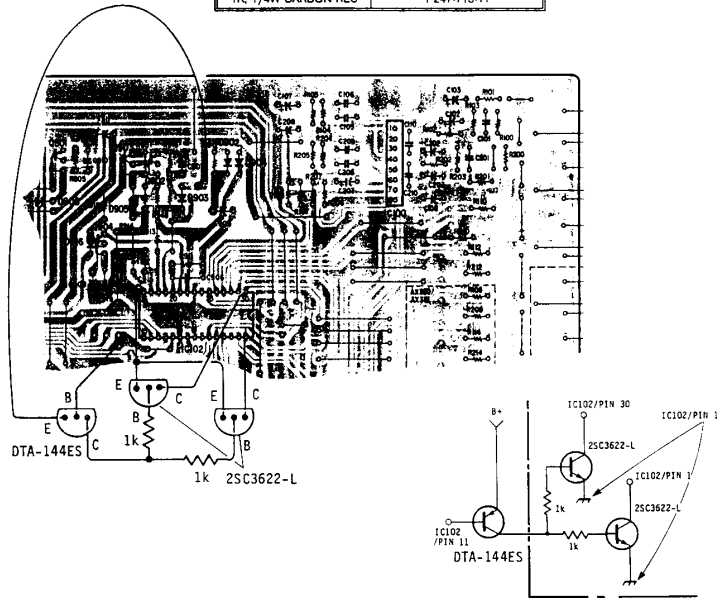
The FM audio from the tuner bleeds through to other inputs. This is most noticeable when the audio signal from the selected source is not present or is between tracks. The following modification need only be done for those customers who find this condition unacceptable.

Solution: Implement the circuit modification as shown below:

DESCRIPTION	PART NUMBER
DTA-144ES	8-729-900-65
2SC3622-L	8-729-107-91
1K, 1/4W CARBON RES	1-247-713-11
