Hi-Fi Products
Service Bulletin

Model: CDP-C910/C90ES

No. 245

Subject: Disc Stops Between Magazine and MD Mechanism

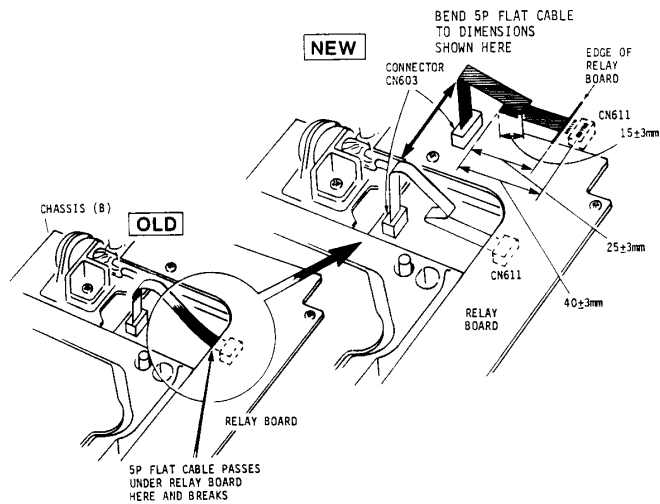
The disc stops between the magazine and the MD Mechanism due to flat Cable 5P which breaks. Cable 5P, which connects CN603 of M2 Motor Board and CN611 of the relay board passes under the relay board and breaks.

Solution: Replace flat Cable 5P with the new type (P/N shown below) and connect it after bending as shown below:

| DESCRIPTION | PART NUMBER |
|---|---|
| 5p FLAT CABLE | 1-690-115-11 |
