Hi-Fi Products
Service Bulletin

Model: TC-W320/W320S/WR520/WR520S/W370/
W411/WR511/WR570

No. 246

Subject: Mechanical Clanking Noise or Unit Exhibits Poor FF
and REW Take-up Torque

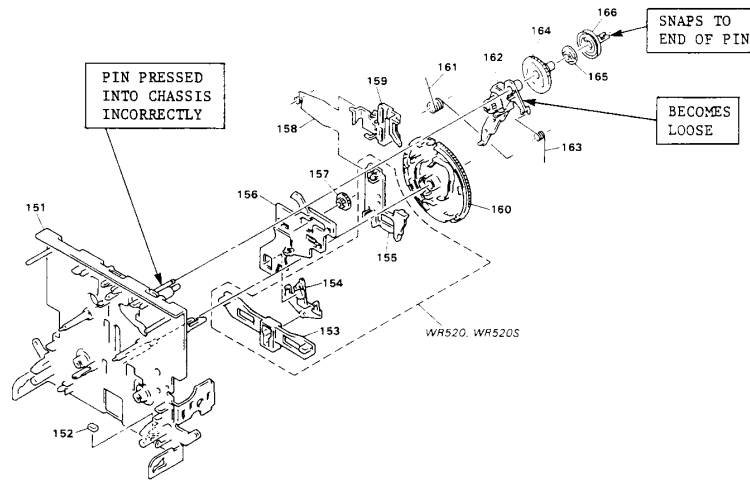
The metal pin which is pressed into chassis Ref. 151 is positioned incorrectly causing Ref. 166 (FR Pulley) to pop off and cause a clanking noise. This in turn causes Ref. 162 (Lever) to become loose therefore resulting in poor FF and REW take-up torque.

Reposition the pin in chassis Ref. 151 so that Reference Numbers 162, 164, 165, and 166 fit snug together with little play and Reference Number 166 snaps on to the pin without risk of popping off. The pin may be repositioned with a small screwdriver.
