Hi-Fi Products
Service Bulletin

Model: TA-E511

No. 247

Subject: Tuner Bleed Through

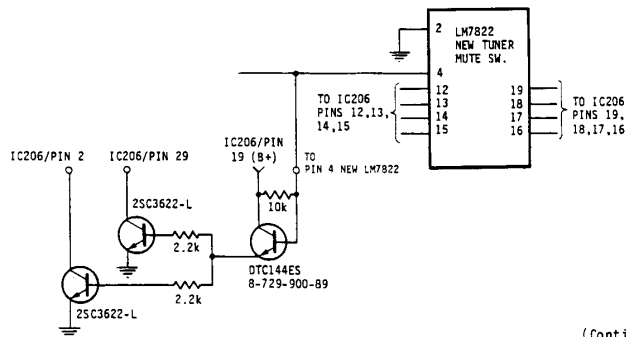
Tuner bleed through while listening to another source (ie. CD, DAT, Phono, Tape). This is most noticeable during a quiet passage or between tracks when the volume is at a high level.

The problem appears to be IC206, the analog switch LC7822. The switch and the unit are working to specification, and the following modification need only be done for those customers who find this condition unacceptable.

Solution: Implement the following circuit. This circuit mutes the tuner when another source is selected and still allows for tuner mute between radio stations or during station search.

The following parts must be added to the existing circuit:
