Hi-Fi Products
Service Bulletin

Model: STR-GX57ES/67ES

No. 249

Subject: Unit Goes Into Protect When Playing For A Couple
Of Hours After Initial Turn-On

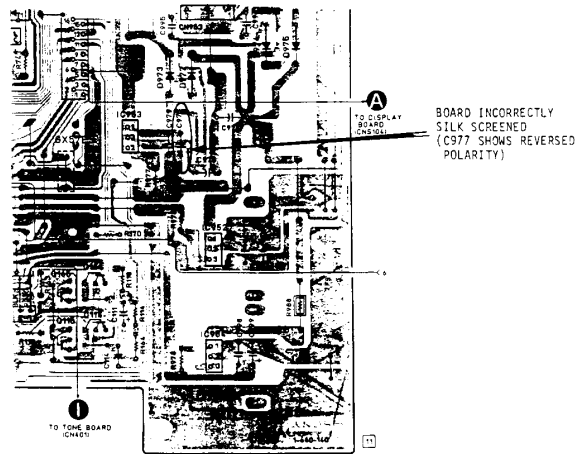
Capacitor C977 is mounted incorrectly on the Main PCB. The capacitor symbol silk screened on the Main PCB for capacitor C977 is shown in reverse polarity. The capacitor is installed in accordance with the silk screen. The Service Manual schematic shows the correct polarity but the PCB layout shows incorrect polarity.

Solution: Replace C977 on units with S/N's which fall into the range shown above. Install the new capacitor opposite to the polarity shown on the PCB silk screen.
