Hi-Fi Products
Service Bulletin

Model: MHC-3600, TA-H3600

No. 257

Subject: AM Interference

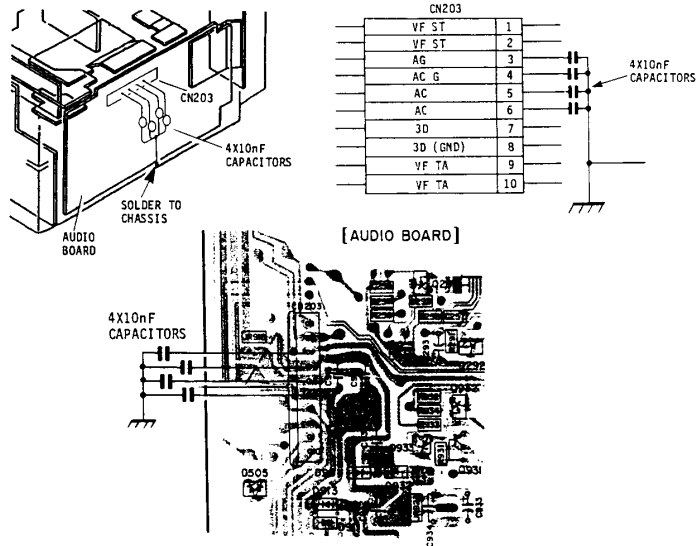
When listening to the CD player, the cassette deck or even the tuner, there might be an unwanted radio station audible. This phenomenon only occurs during the evening and night.

To correct this problem, connect four (4) 10nF ceramic capacitors between the chassis (GND) and pins 3,4,5 and 6 of CN203 on the audio board. At the ground side, twist all the capacitor leads together and solder them onto the chassis as shown below.
