Hi-Fi Products
Service Bulletin

Model: TAN-611

No. 263

Subject: Unit Goes Into Protect Immediately Following Power-up. **Date:** April 27, 1992

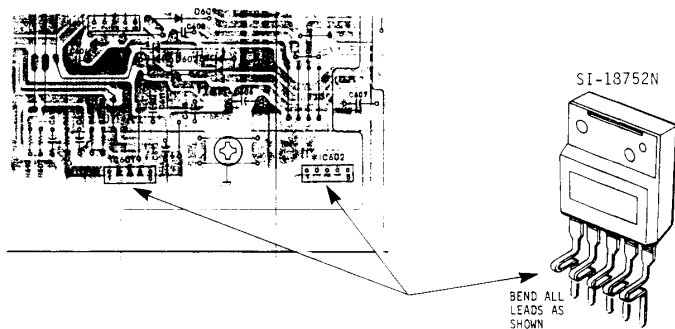
Symptom:
(51) When unit is powered on, the speaker relay turns on and audio is heard from the front speakers for a brief instant before the unit goes into protect.

Solution: The problem is due to broken solder connections on IC601 and IC602. This is caused by excessive movement between the PC board and mounted components IC601 and IC602. Remove IC601 and IC602 and provide strain relief by bending leads as shown in diagram below. If the leads are too short, replace IC601 and IC602 with new parts and bend leads as shown in diagram.
