Hi-Fi Products
Service Bulletin

Model: CDP-S107

No. 266

Subject: Translation Board Marked Incorrectly: CLV and Sled Motor Connections. **Date:** May 29, 1992

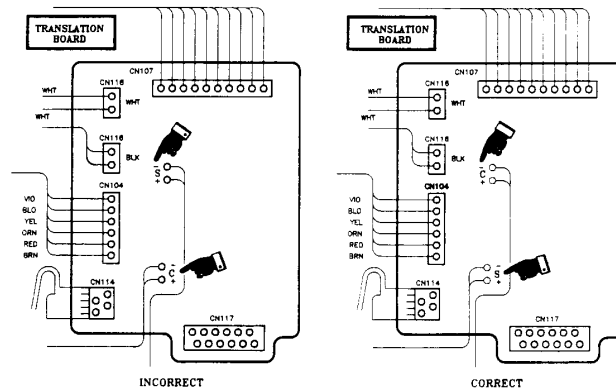
Symptom: (**)
The connecting points on the translation board where the wires for the CLV motor and sled are soldered, are incorrectly marked.

Solution: The translation board should be marked as shown below:
