Hi-Fi Products
Service Bulletin

Model: TC-K620/K650ES/K670/K677ES/K690/K679ES No. 275R1

Subject: Tape Gets Wrinkled

Date: December 30, 1992

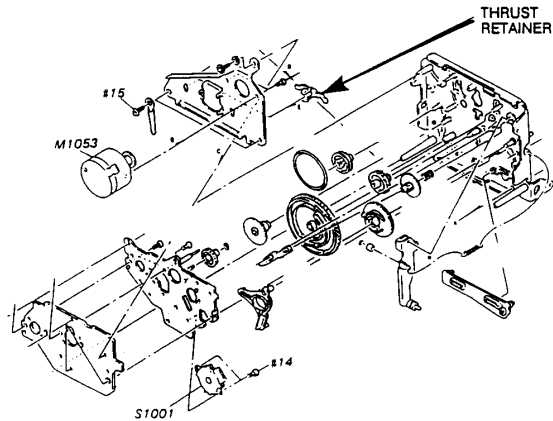
The tape gets wrinkled by the capstan and pinch roller. The thrust retainer for the flywheel gets deformed so that the shaft of the capstan easily moves back and forth causing unstable tape path during play.

Solution: Replace the thrust retainer with the new type as shown in the chart below:
