Hi-Fi Products
Service Bulletin

Model: TC-K670,TC-K677ES

No. 277

Subject: Poor Sound At High Frequencies

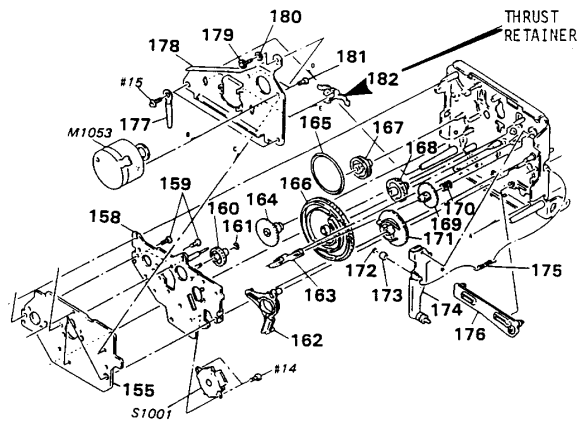
High frequency audio is of poor quality due to a deformed capstan thrust retainer (Ref. 182 - on page 32 of the Service Manual). The deformed thrust retainer allows excessive movement of the capstan which results in an improper tape path and poor quality high frequency audio.

Solution: Replace the thrust retainer with the part shown below:

REFERENCE	DESCRIPTION	PART NUMBER	
		INCORRECT	CORRECT
182	RETAINER, THRUST CAPSTAN	3-575-321-00	X-3365-071-1
