Hi-Fi Products
Service Bulletin

Model: D-4140/T4/T40

No. 289

Subject: Caution When Replacing IC801

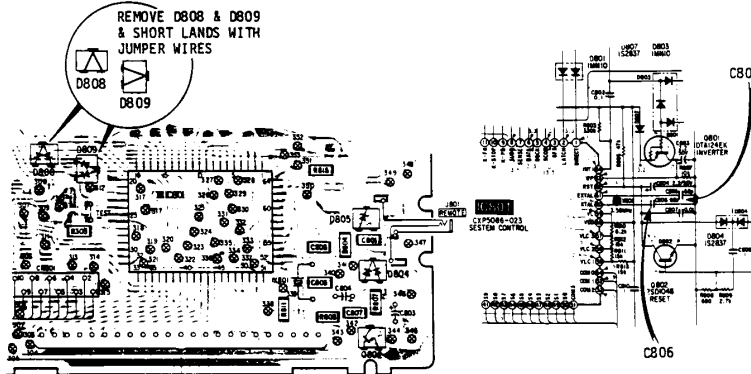
If you change IC801

DESCRIPTION	PART NUMBER
FORMER IC	CXP-5086-026Q	8-752-804-07
NEW IC	CXP-5086-602Q	8-752-809-23

1. Remove D808 and D809 and then short the lands for those diodes.
2. Change the value of C805 and C806 from 68pF to 47pF.

REFERENCE	DESCRIPTION		PART NUMBER
	FORMER	NEW	
C805 & C806	68pF	47pF	1-163-109-00
