Model: HCD-H7/H1500

No. 290

Subject: Improvement of Wow Problem

Date: August 14, 1992

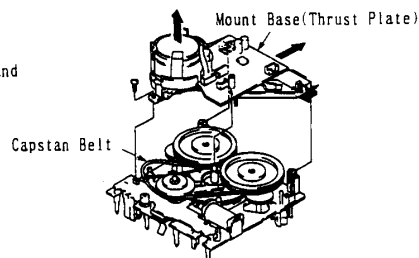
Symptom:
(57) Poor wow caused by twisted capstan belt.

1. Remove the Mount Base(Thrust Plate) and the Capstan Belt.
