Hi-Fi Products
Service Bulletin

Model: DTC-87ES

No. 309

Subject: Tape Won't Load

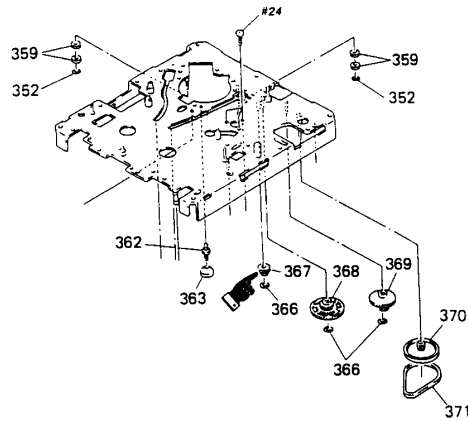
MECHANISM SECTION 5 (DATM-51)

Mechanism will not load tape due to a cracked loading gear B (ref. 367) which is damaged by mechanical overload.

Solution: Replace loading gear B (ref. 367) with an improved type as shown in the chart below.
