Hi-Fi Products  
Service Bulletin

**Model:** FH-B150 / HCD-H150

**No. 310**

**Subject:** Hum Noise In Headphone

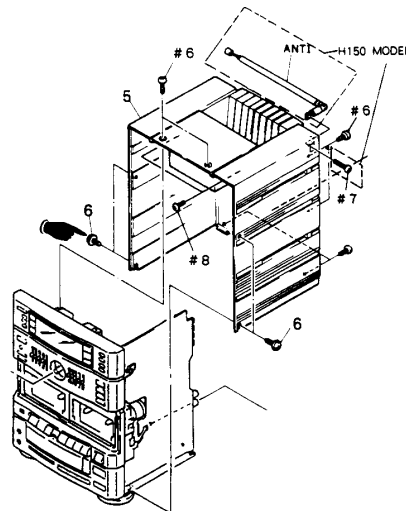
A hum noise is intermittently present on the headphone output signal. It may disappear when the set is moved or tapped on. The lower left-hand cabinet screw (ref. 6) is too long and touches a GND pattern on the headphone amplifier board (jack board). This causes a ground loop and results in the hum noise.

**Solution:** Replace the lower left-hand cabinet screw with the part number as shown in the chart below.

DESCRIPTION	PART NUMBER
SCREW (3 X 6)	3-363-099-21
