Hi-Fi Products
Service Bulletin

Model: CDP-C100/C15ESD/C9ESD/C90ES/C900
/C910

No. 311

Subject: New Type Disc Magazine Will Not Eject

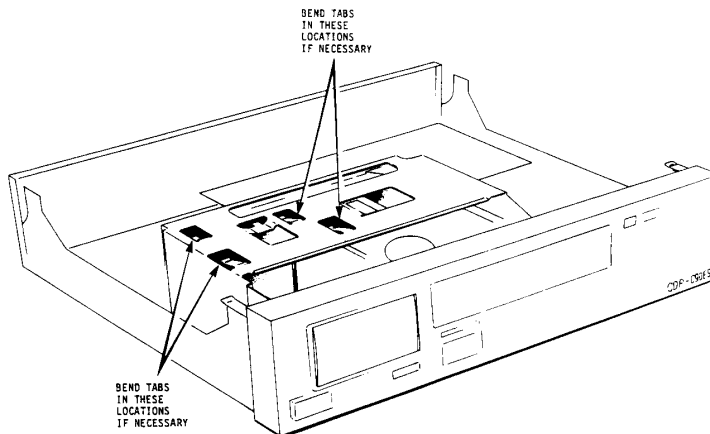
The new type XA-10B disc magazine will not eject from the unit consistently.

Since the new type XA-10B disc magazine has a slightly higher profile, you must bend the tabs on the mechanism housing (see drawing) which are located just above where the cartridge is inserted into the machine to provide clearance.

Note: Bend tabs to the point where the disc magazine will consistently eject from the unit.
