Hi-Fi Products
Service Bulletin

Model: D-311

No. 315

Subject: Incompletion Of Full Charge

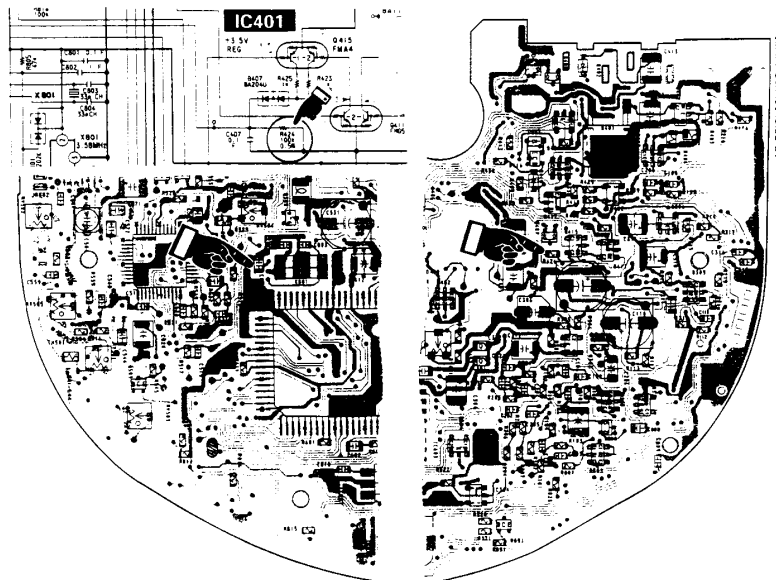
Charge lamp lights on momentarily when charge button is pressed but full charge has not been completed.

- Solution:**
1. Check the VCC of microprocessor using the terminals of C801.
 2. If it is less than 3.45V, change the value of R424.

REF	FORMER		NEW	
	DESCRIPTION	PART NUMBER	DESCRIPTION	PART NUMBER
R424	METAL CHIP 100KOHMS	1-218-740-11	METAL CHIP 75KOHMS	1-218-296-11
