Hi-Fi Products
Service Bulletin

Model: DTC-57ES / 75ES / 87ES / 700 / 750

No. 317

Subject: Momentary loss of audio at the same point on a known good tape.

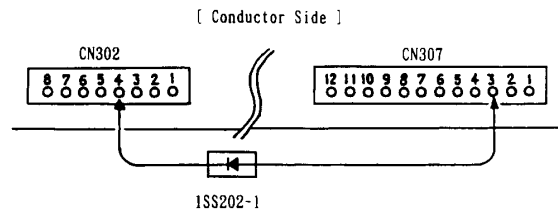
DTC-75ES / 700

When playing back pre-recorded tapes which have had no previous problems, the audio is lost momentarily at the same point on the tape. This problem is caused by a malfunction in the unit which momentarily sets the unit into the record mode when the power switch is turned on or off and a tape is left in the unit.

Add one diode (shown in the chart below) between pin no. 4 on connector CN302 and pin no. 3 on connector CN307 on the Main board (mount as shown in diagram below).

DESCRIPTION	PART NUMBER
1SS202-1	8-719-107-94
