Hi-Fi Products
Service Bulletin

Model: DTC-700 / 75ES

No. 323

Subject: Momentary loss of audio when listening to a tape which was recorded in the LP mode.

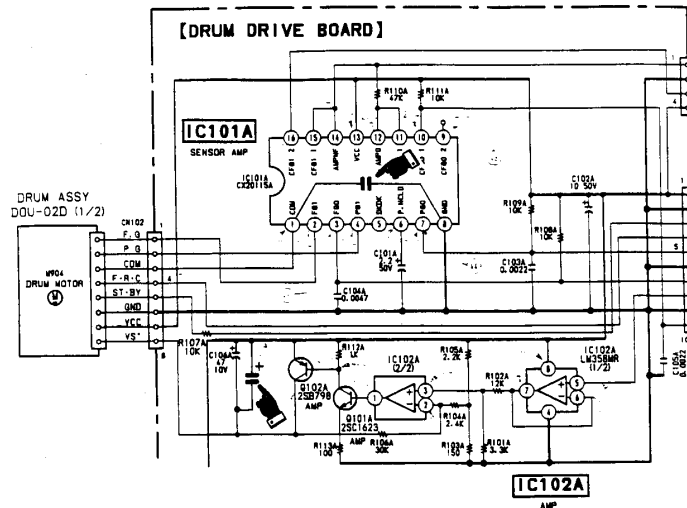
(51) When playing back tapes recorded in the LP mode, dropouts may occur at the same point on the tape. The problem is caused by noise picked up by the FG coil during recording.

Add a 0.01 μ F capacitor between pin 1 and pin 8 of IC101 on the Drum drive board. Add a 100 μ F capacitor in parallel with C106 on the Drum drive board.
Note: The schematic diagram shows C106A for C106.

DESCRIPTION	PART NUMBER
0.01 μ F CERAMIC CAPACITOR	1-162-306-11
100UF 10V ELECT CAPACITOR	1-126-177-11
