Hi-Fi Products  
**Service Bulletin**

**Model:** D-802K

**No. 345**

**Subject:** No Lighting Of Pilot Lamp Or LEDs - C-901  
Inserted Backwards

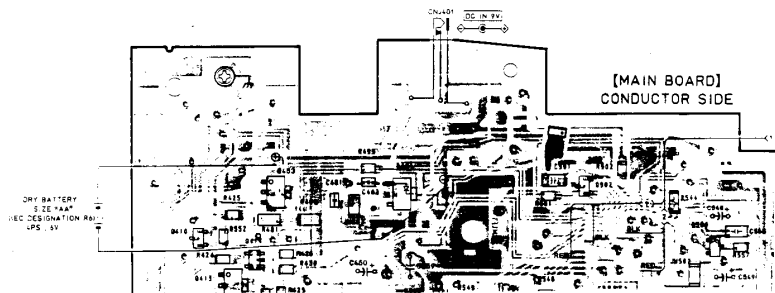
No lighting of pilot lamp or LEDs

**Solution:** Inspect C-901 for proper polarity. If C-901 is inserted backwards, then replace C-901 (observing proper polarity).

REF	DESCRIPTION	PART NUMBER
C-901	TANTAL. CHIP 2.2UF	1-135-179-21
