Hi-Fi Products
Service Bulletin

Model: DXA-H2750/H3750

No. 351

Subject: Tuner Bleed Through

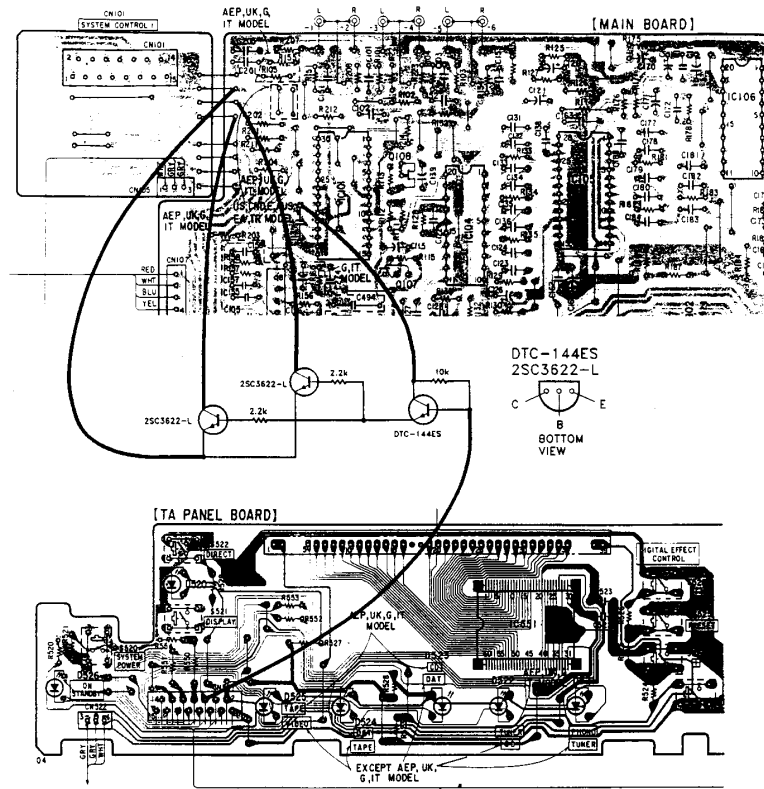
Tuner bleed through while listening to another source (ie. CD, DAT, Phono, Tape). This is most noticeable during a quiet passage or between tracks when the volume is at a high level.

The problem appears to be due to IC101 (Function Switch type LC7822). The problem is caused by the Tuner which is active in all modes and bleeds through internally on IC101.

Implement the following circuit. This circuit mutes the Tuner when another source is selected but still allows for tuner mute between stations or during station search.

The following parts must be added to the existing circuit:

1. Connect the 2SC3622-L transistors(2), 2.2K ohm resistors (2), 10K ohm resistor (1) and the DTC-144ES transistor (1) as illustrated.
2. Make sure all wires and leads have been neatly clipped and do not interfere with the normal operation of the unit.
3. Testing the unit should include the following:
 - Select the tuner source and verify that tuner audio is present.
 - Select a different source and verify that the tuner audio does not bleed through to the selected source when the volume is set to the maximum level.
