Hi-Fi Products
Service Bulletin

CSA-13

Model: CPM-300; D-122CK/802K; DCC-E55/E455/E905 **No. 352**

Subject: Cigarette Lighter Plug Blows Vehicle's Fuse **Date:** August 23, 1993

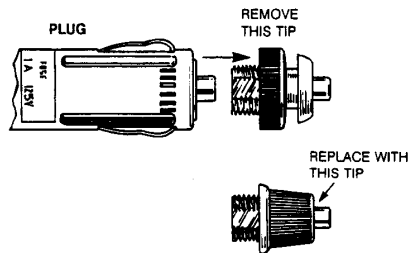
Symptom:
(11) The fuse in the vehicle's cigarette lighter circuit blows when the power cord plug is inserted into the lighter socket.

Solution: Replace the tip of the power cord plug with part shown below.

REF	DESCRIPTION	PART NUMBER
-	TIP, PLUG	4-962-384-01
