Hi-Fi Products
Service Bulletin

Model: DTC-59ES/690

No. 358

Subject: Intermittent Audio, Mechanism Wrinkles Tape

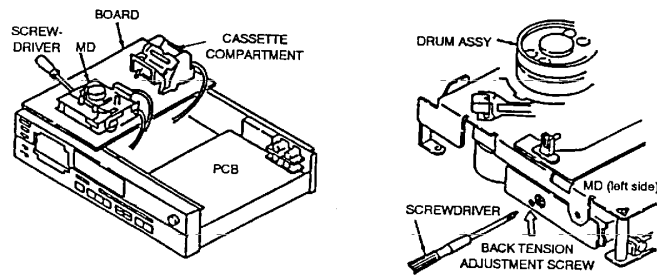
Figure 2

Note: Back tension adjustment is necessary following replacement of the compression springs as the tension tends to increase after replacing the springs.

1. Remove the mechanical deck and the cassette compartment from the unit and separate the two assemblies. Place the two assemblies on a board without disconnecting any electrical connections (see Figure 2).
2. Put the unit in the test mode, insert a TW-7131 torque test tape (P/N 8-909-708-71) and press the forward button on the unit.
3. Adjust the back tension by slightly turning the adjustment screw located on the left side of the mechanism.
4. Changing modes once or twice (ie. PLAY - PAUSE - PLAY) during the procedure ensures an accurate adjustment. The back tension should be adjusted to 5.0 g/cm to 6.0 g/cm.
5. Check that this value remains steady for one revolution of the torque meter. This adjustment should be completed before one minute has elapsed as the torque will begin to vary when the plunger begins to heat up.
