Hi-Fi Products
Service Bulletin

Model: CDP-C701/801ES

No. 362

Subject: Intermittent Pop Noise in Left Channel Output

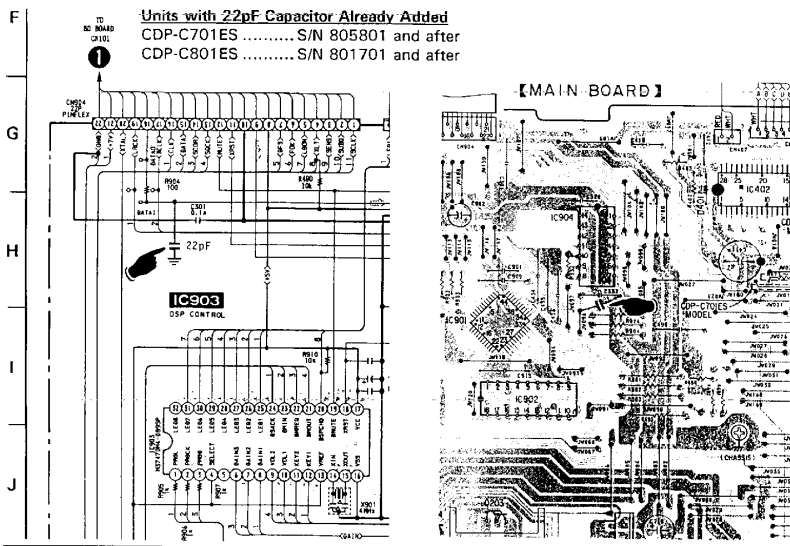
Intermittently, a "pop" or "snap" noise may be heard in the left channel of any output, either fixed line, variable line or headphone on some units. It is most noticeable during very quiet passages or in-between tracks. It is not dependent on the disc being used.

Add a capacitor as shown below. The units with Serial Numbers higher than those listed below already have the capacitor added. Some units below the listed Serial Numbers may also have the capacitor added. Be sure to check before adding.

REF	DESCRIPTION	PART NUMBER
NONE	22PF CERAMIC CAPACITOR	1-162-207-31
