Hi-Fi Products Service Bulletin

Model: CDP-H3600

No. 367

Subject: Preventing Damage To Q101

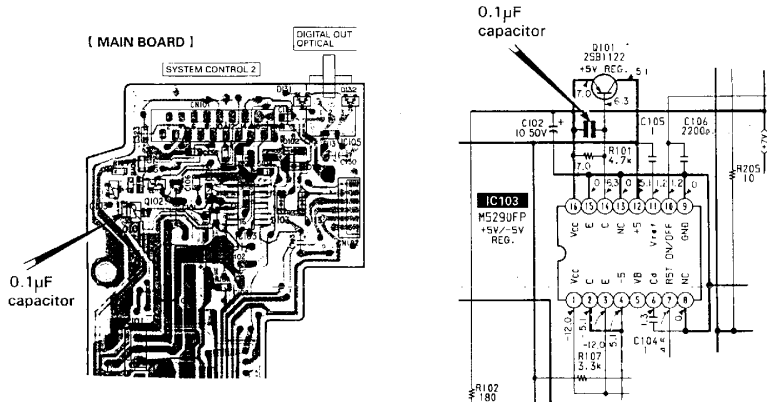
(**) The unit has no power because Q101 on the Main MCB is damaged.

Replace Q101, and prevent it from being damaged again by adding a 0.1µF capacitor across its base and emitter.

This capacitor has already been mounted on *some* version "A" Main boards, and *all* version "C" Main boards. Version "A" Main boards are silkscreened with the number 1-638-990-__; version "C" Main boards are silkscreened with the number 1-640-541-__. Add the capacitor only to version "A" Main boards which do not already have the capacitor mounted.
