Hi-Fi Products
Service Bulletin

Model: MDS-101

No. 370

Subject: Non-Sony Discs Jam During Loading, Or Load Slowly

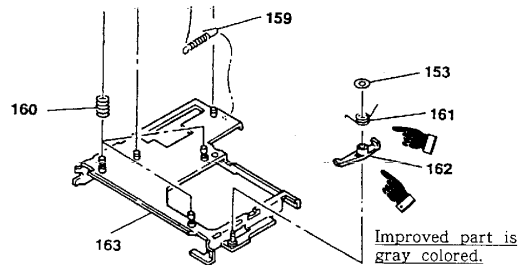
In some units, discs which are not made by Sony may occasionally jam during loading, or may load slowly.

If a unit is exhibiting this problem, install the parts kit shown below. The kit consists of an improved SHUTTER LEVER and TORSION SPRING.

REF	DESCRIPTION	PART NUMBER
-	LEVER (SHUTTER L) KIT	X-4944-745-1
