**Hi-Fi Products  
Service Bulletin**

**Model:** CDP-CX100/CX100S

**No. 380**

**Subject:** Hum or Noise Problem

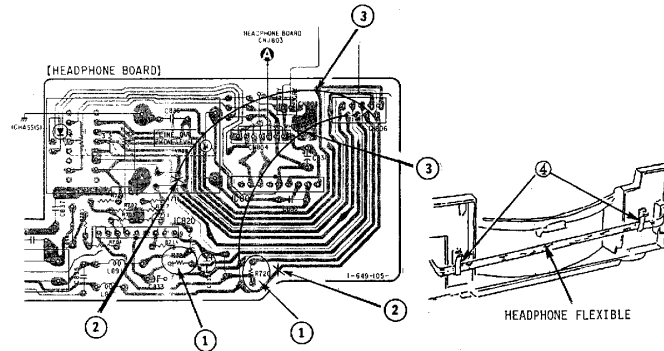
Noise or Hum is heard in the headphone or Variable line out due to a poor ground pattern on the headphone board.

1) Change the value of R720 and R721 (headphone bd.) from 33 ohm to 100 ohm.

2) Cut the pattern as follows.

3) Add 2 jumper wires as follows.

4) Secure the flexible headphone wire into the cord holder.
