Hi-Fi Products
Service Bulletin

Model: TA-AV411

No. 382

Subject: The Output Transistors on the AMP-L and AMP-R **Date:** March 18, 1994
Boards Become Defective.

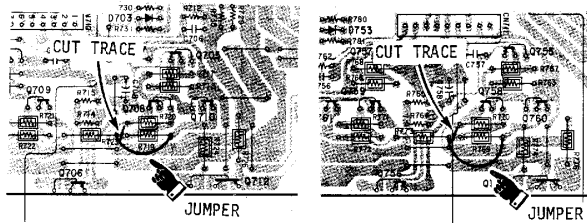
The output transistors on the AMP-L and AMP-R boards (Q705, Q706, Q755 and Q756) run hot and become defective.

A mistake in the PCB pattern on the AMP-L and AMP-R boards causes the symptom described above. Cut the pattern on the PCB as shown in the diagram below and add the jumper wire on the AMP-L and AMP-R boards.
