Hi-Fi Products
Service Bulletin

Model: MHC-2750

No. 383

Subject: Tuner Crosstalk at Phono Input

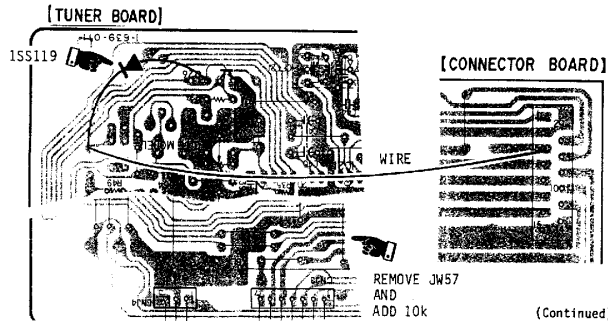
ST-H2750

Tuner crosstalk at the Phono input.

- 1) Remove JW57 and insert a 10K ohm 1/4W resistor (1-249-429-11) in its place.
- 2) Add a 1SS119 diode (8-719-911-19) and a wire to pin 5 of CNJ601 (connector board) as shown.
