Hi-Fi Products  
**Service Bulletin**

**Model:** MHC-1600/3600, CDP-H3600, HCD-H1600      **No. 386**

**Subject:** CD Synchronize Feature Inoperable Following Repair of Unit.      **Date:** March 18, 1994

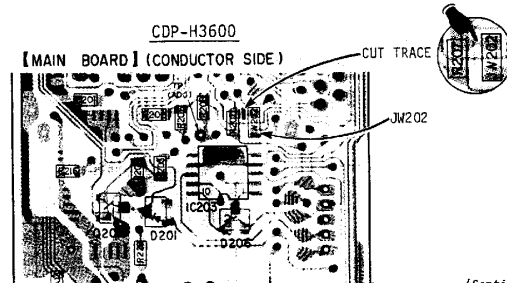
Following replacement of the MAIN Board, BD Board or Micon uPD75116GF, the CD synchronize feature becomes inoperable. This symptom occurs after any one of the following repairs have been made:

The version of the replacement micon uPD75116GF has been updated which results in mis-communication between it and the DSP IC. The following circuit change(s) should be made:

CDP-H3600 (MAIN Board):  
Cut the pattern connecting pin 18 of IC201 to JW202.
