Hi-Fi Products
Service Bulletin

Model: CDP-CX100

No. 388R1

Subject: The unit does not find a selected CD

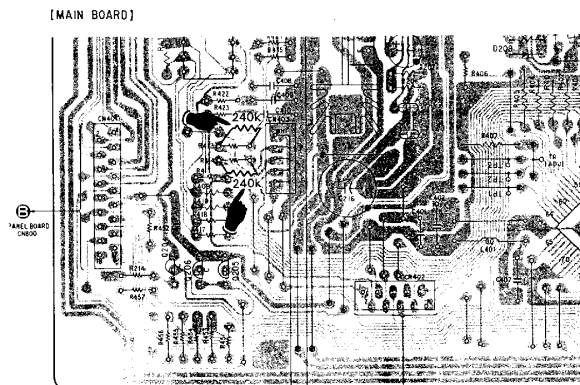
When loading more than 60 discs the CDP-CX100 may experience a problem finding a selected disc. The problem is caused by the weight of the discs, which slows the rotation of the rotary table. The slowed rotary table causes the unit to engage its *Safety System*. Note :The *Safety System* causes the table to rotate in an opposite direction if a finger or an object is caught in the mechanism while it is turning.

Solution: To increase the drive torque of the table, add a 240k resistor in parallel with R413 and R414. These resistors are located on the Main board, .

QTY	DESCRIPTION	PART NUMBER
2	240K OHM 1/4 WATT RESISTOR	1-247-888-11
