Hi-Fi Products
Service Bulletin

Model: TC-WR901ES

No. 391

Subject: No Operation With Remote Commander

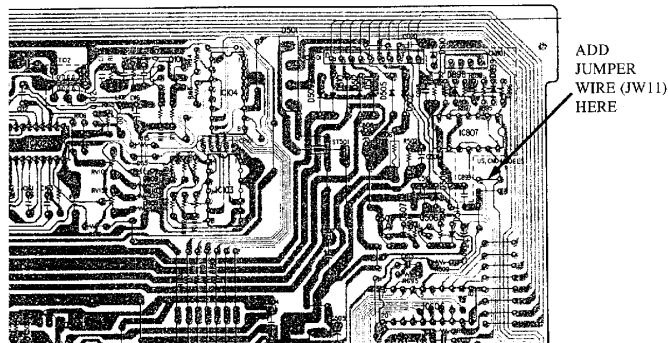
[MAIN BOARD]

(25) The unit will not respond to IR Remote Commands.

Solution: Install missing jumper wire, JW11, onto the Main board as shown below.
