Hi-Fi Products
Service Bulletin

Model: MHC-510

No. 393

Subject: Two Versions of Display/Function Control IC501 **Date:** May 13, 1994

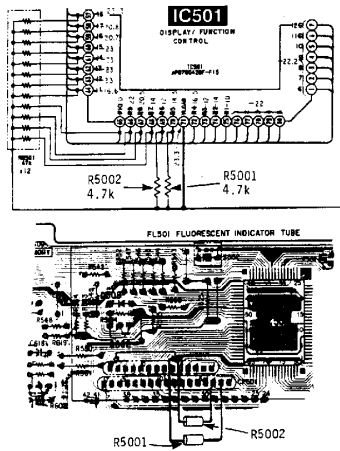
There are two versions of the Display Controller IC501, μ PD78042-GF-028 (8-759-173-77) and μ PD78042-GF-0213BQ (8-759-088-85). The difference between the two versions is as follows:

μ PD78042-GF-0213BQ: R5001 and R5002 are NOT included.

μ PD78042-GF-028: R5001 and R5002 are included.

Solution: When using P/N 8-759-088-85 listed in the Service Manual, the 47K ohm resistors R5001 and R5002 (P/N 1-249-437-11) need to be added between pins 69 and 70 of IC 501 and VLOAD (pin 71 of IC501). If these resistors are not added the display will flicker.
