Hi-Fi Products
Service Bulletin

Model: FH-B5CD/B50CD/B150, MHC500/1100 **No.** 401
HCD-H5/H50/H55/H500/H1100

Subject: Distorted recordings from CD **Date:** June 24, 1994

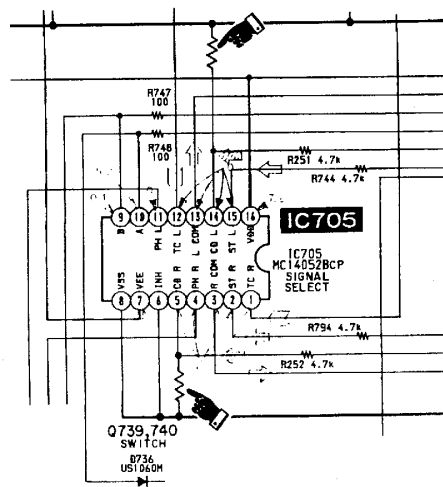
Symptom:
(53) A recording from a CD may sound distorted during playback.

Solution: Add two 4.7K 1/4 W resistors (1-249-425-11) between IC705 pins 5 and 14 to ground.
See diagram below.
