Hi-Fi Products Service Bulletin

Model: STRGX800ES

No. 418

Subject: No Sound with 'Tape Monitor' mode while receiving a Radio Broadcast . Applicable S/N range, until ~ #806,508

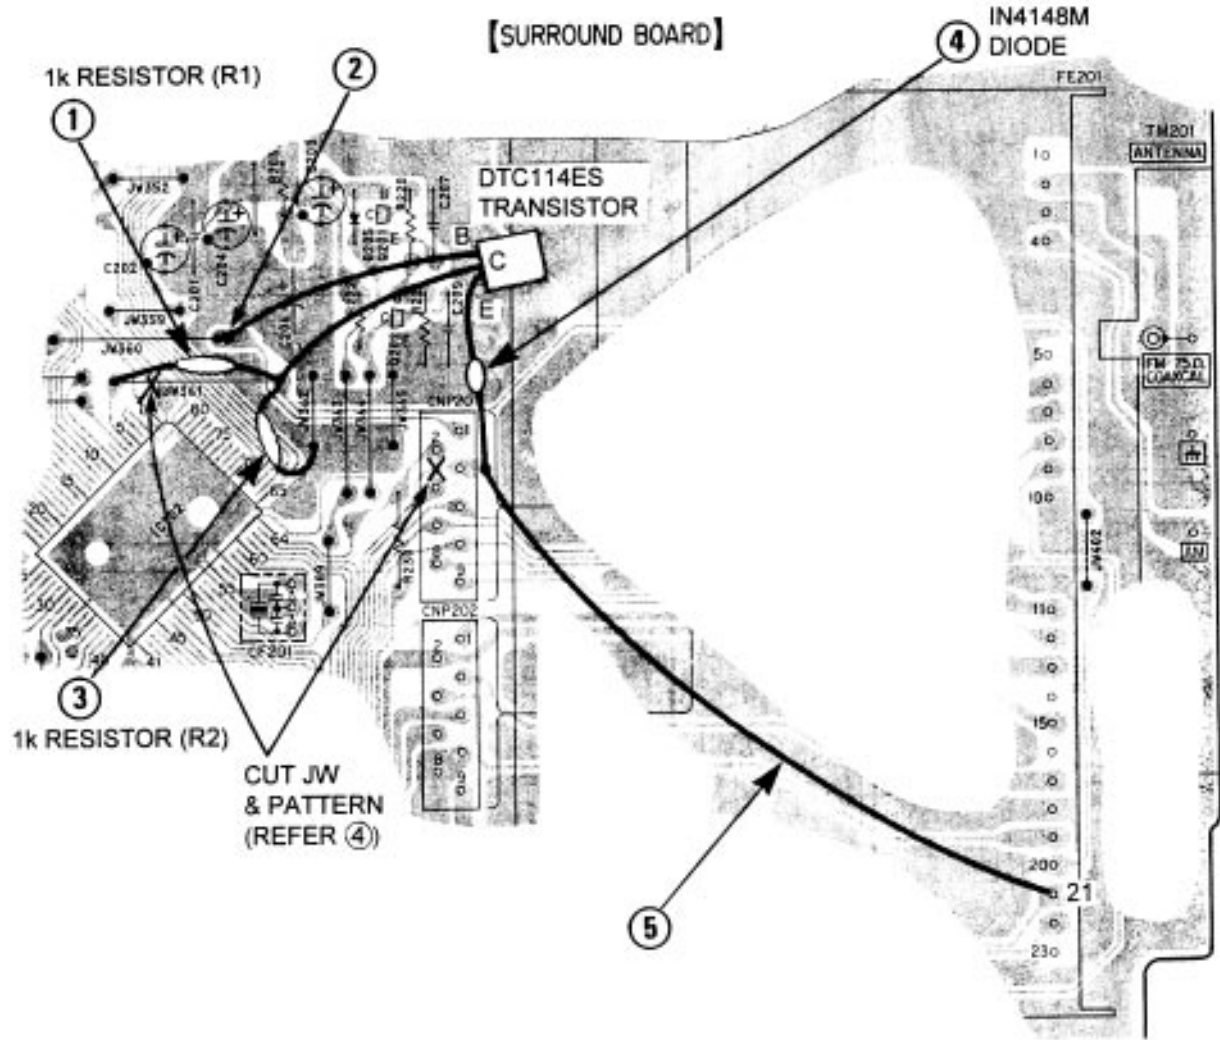
No Sound in 'Tape Monitor' mode while receiving a Radio Broadcast. This is due to a Microprocessor software bug.

Solution: Add the following circuit between IC201 (Micro) and the FM/AM tuner pack (FE201).

1.) Remove JW361 and mount a 1K resistor in its place. (Designate this resistor R1).

2.) Mount the DTC-114ES base lead to the JW360 pattern land. (See diagram)

3.) Mount the other 1K resistor (Designate R2) between the collector of the DTC-114ES and ground. The transistors collector lead and resistor R2 should now be soldered to the other side of R1 , which is already mounted in place of JW361. (See diagram)

4.) Cut the pattern land of the #3 pin of CNP201. Mount the 1N4148M diode between the emitter of the DTC-114ES (Anode to transistor, Cathode to land) and the isolated land of the cut foil pattern. (See diagram).

5.) Mount the 90MM jumper wire between the cathode of the diode 1N4148M and pin #21 of the FM/AM Tuner Pack, FE201. (Continued)
