Hi-Fi Products Service Bulletin

Model: SAVA3

No. 430

Subject: Popping Noise in Rear Channel

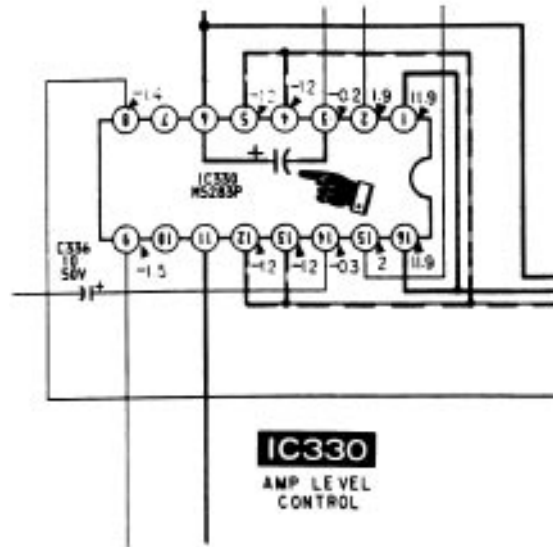
When in Dolby Pro-Logic mode a popping noise is randomly heard in the rear channel.

Add a 10uf 50V electrolytic capacitor (part number 1-126-059-11) to IC330, the Amp Level Control IC. IC330 is located on the Dolby Board. Solder the capacitor across pin 3 (negative side of capacitor) to pin 6 (ground). See diagram below.
